MANDAN DIESEL FUEL REMEDICATION PROJECT

PRESENTATION FOR

JANUARY 22, 2020

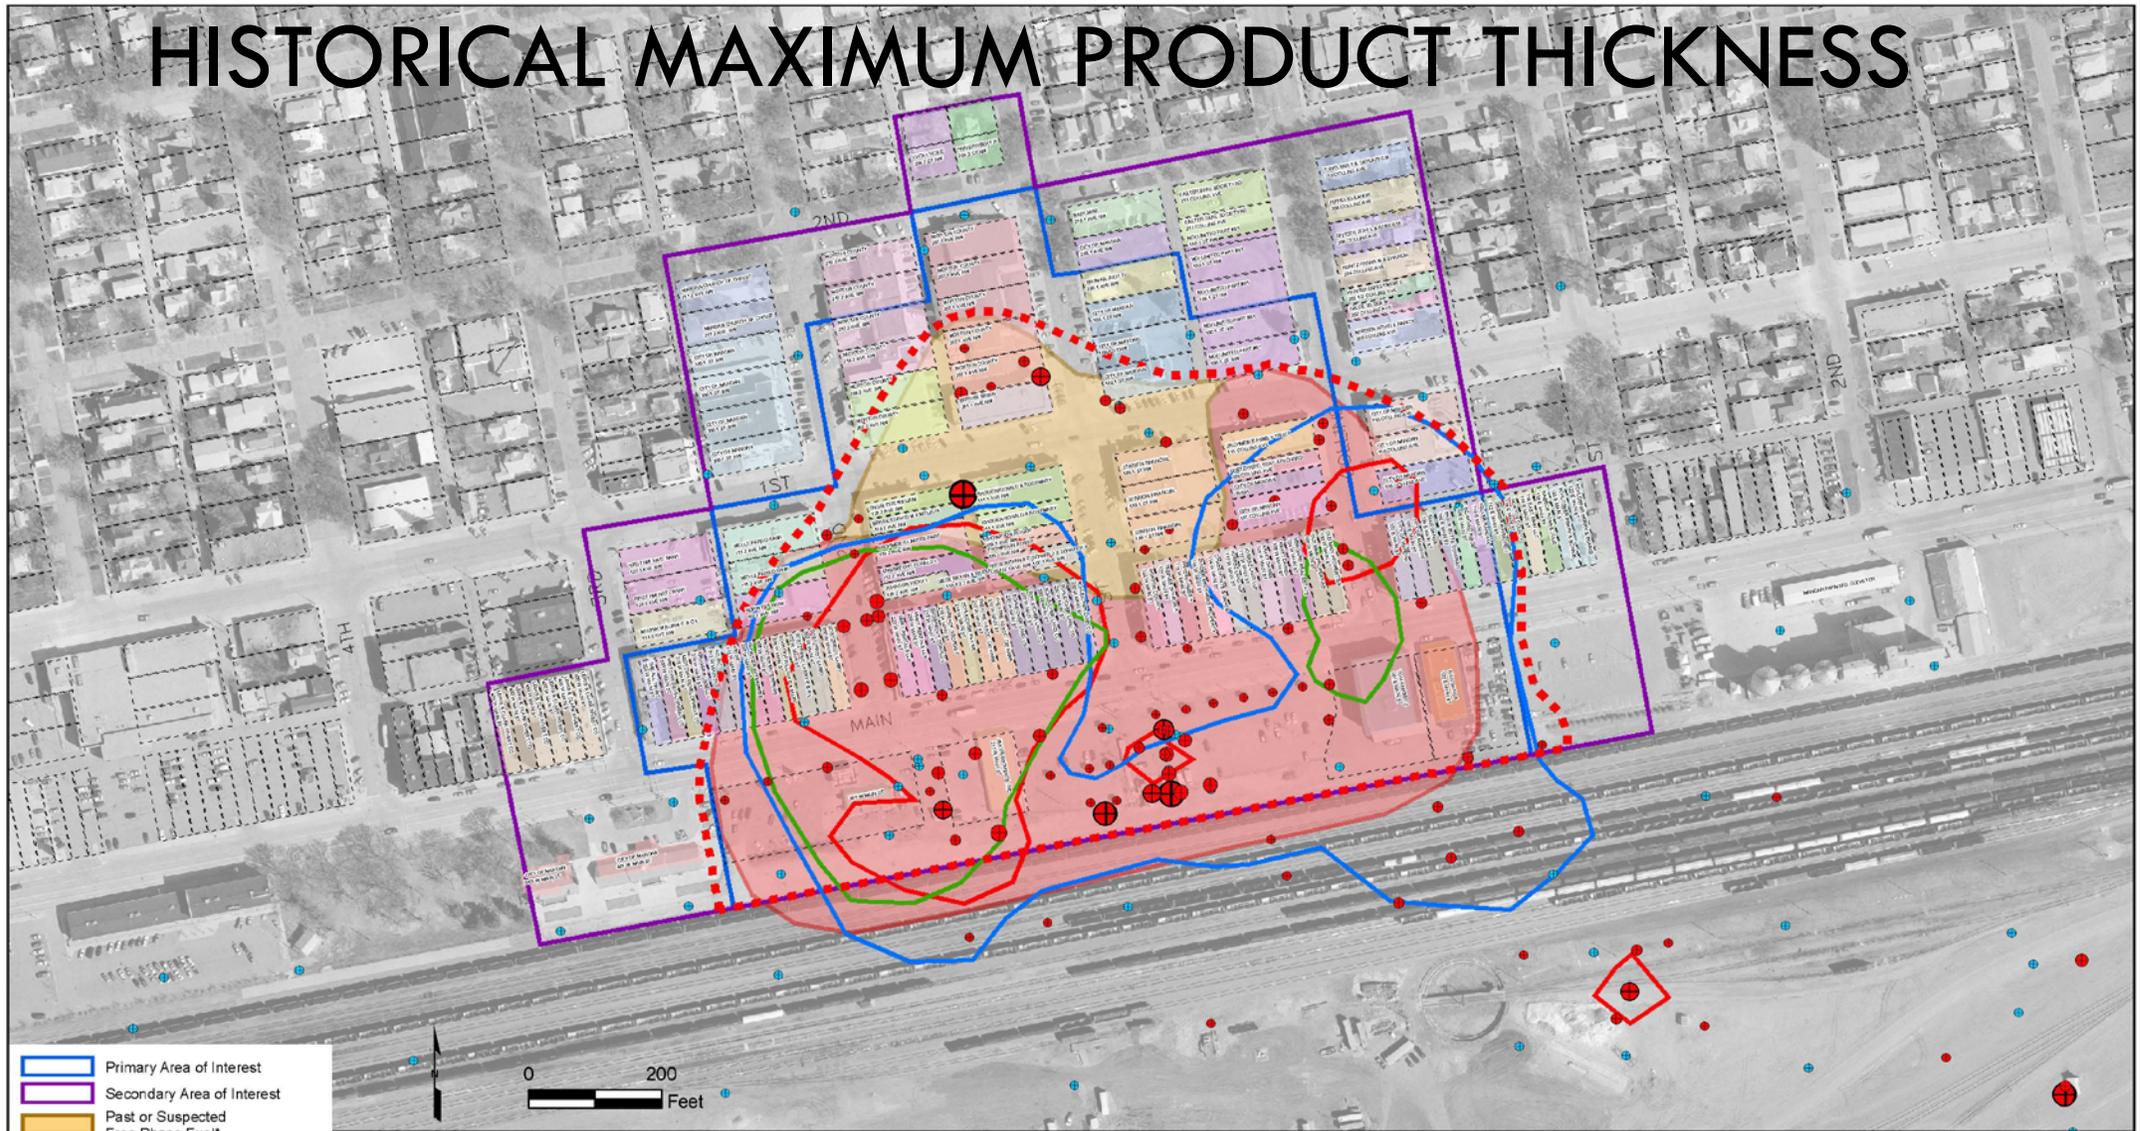
NDDH MANDAN REMEDIATION TRUST DOWNTOWN MANDAN REMEDIATION PROJECT MANDAN, NORTH DAKOTA		
HISTORICAL MAXIMUM PRODUCT THICKNESS THROUGH 2004		
FILE: G3MANDAN02D.MXD	DATE: 02/18/2005	FIGURE: 12

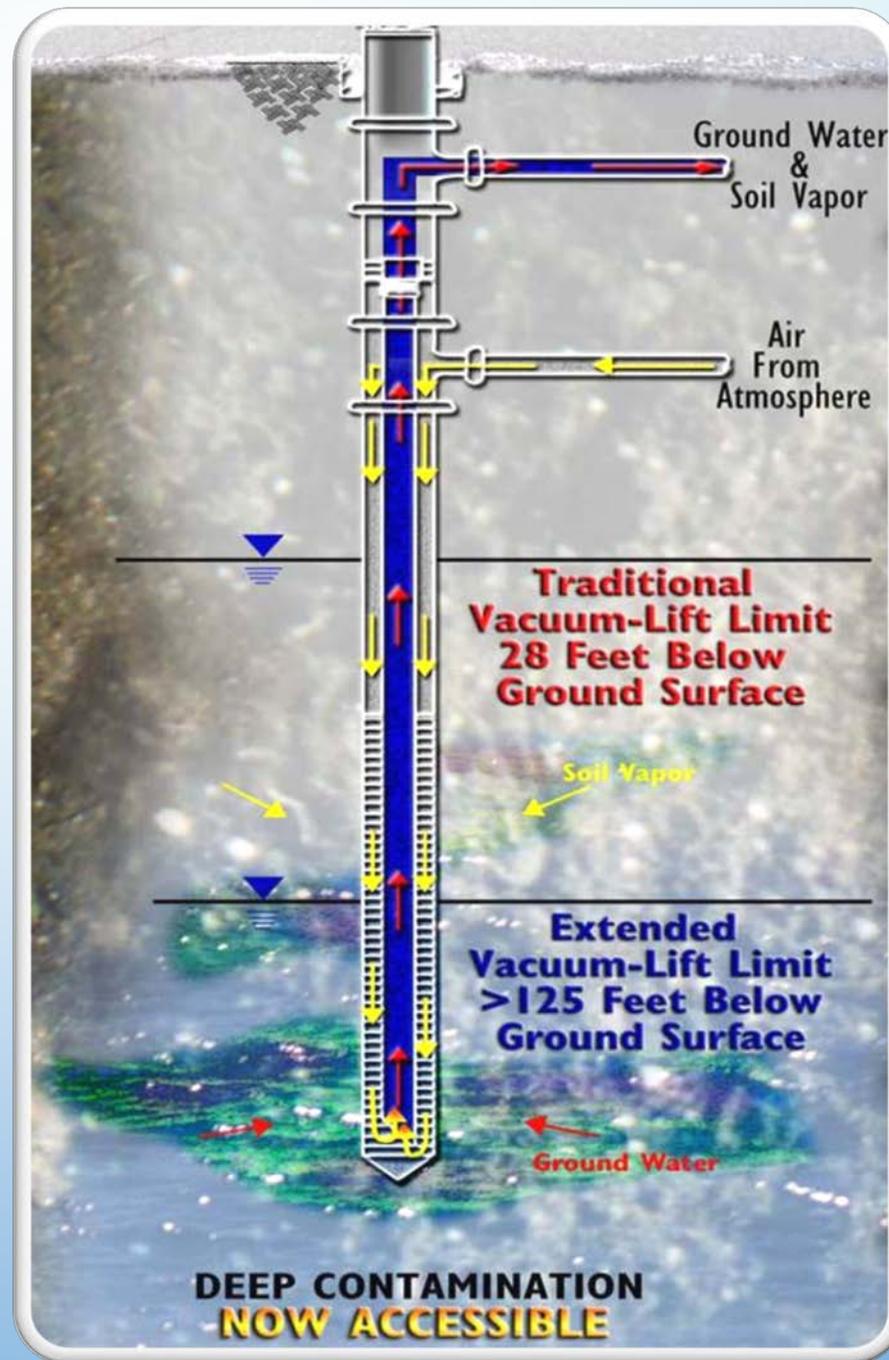
MULTI PHASE EXTRACTION WELL

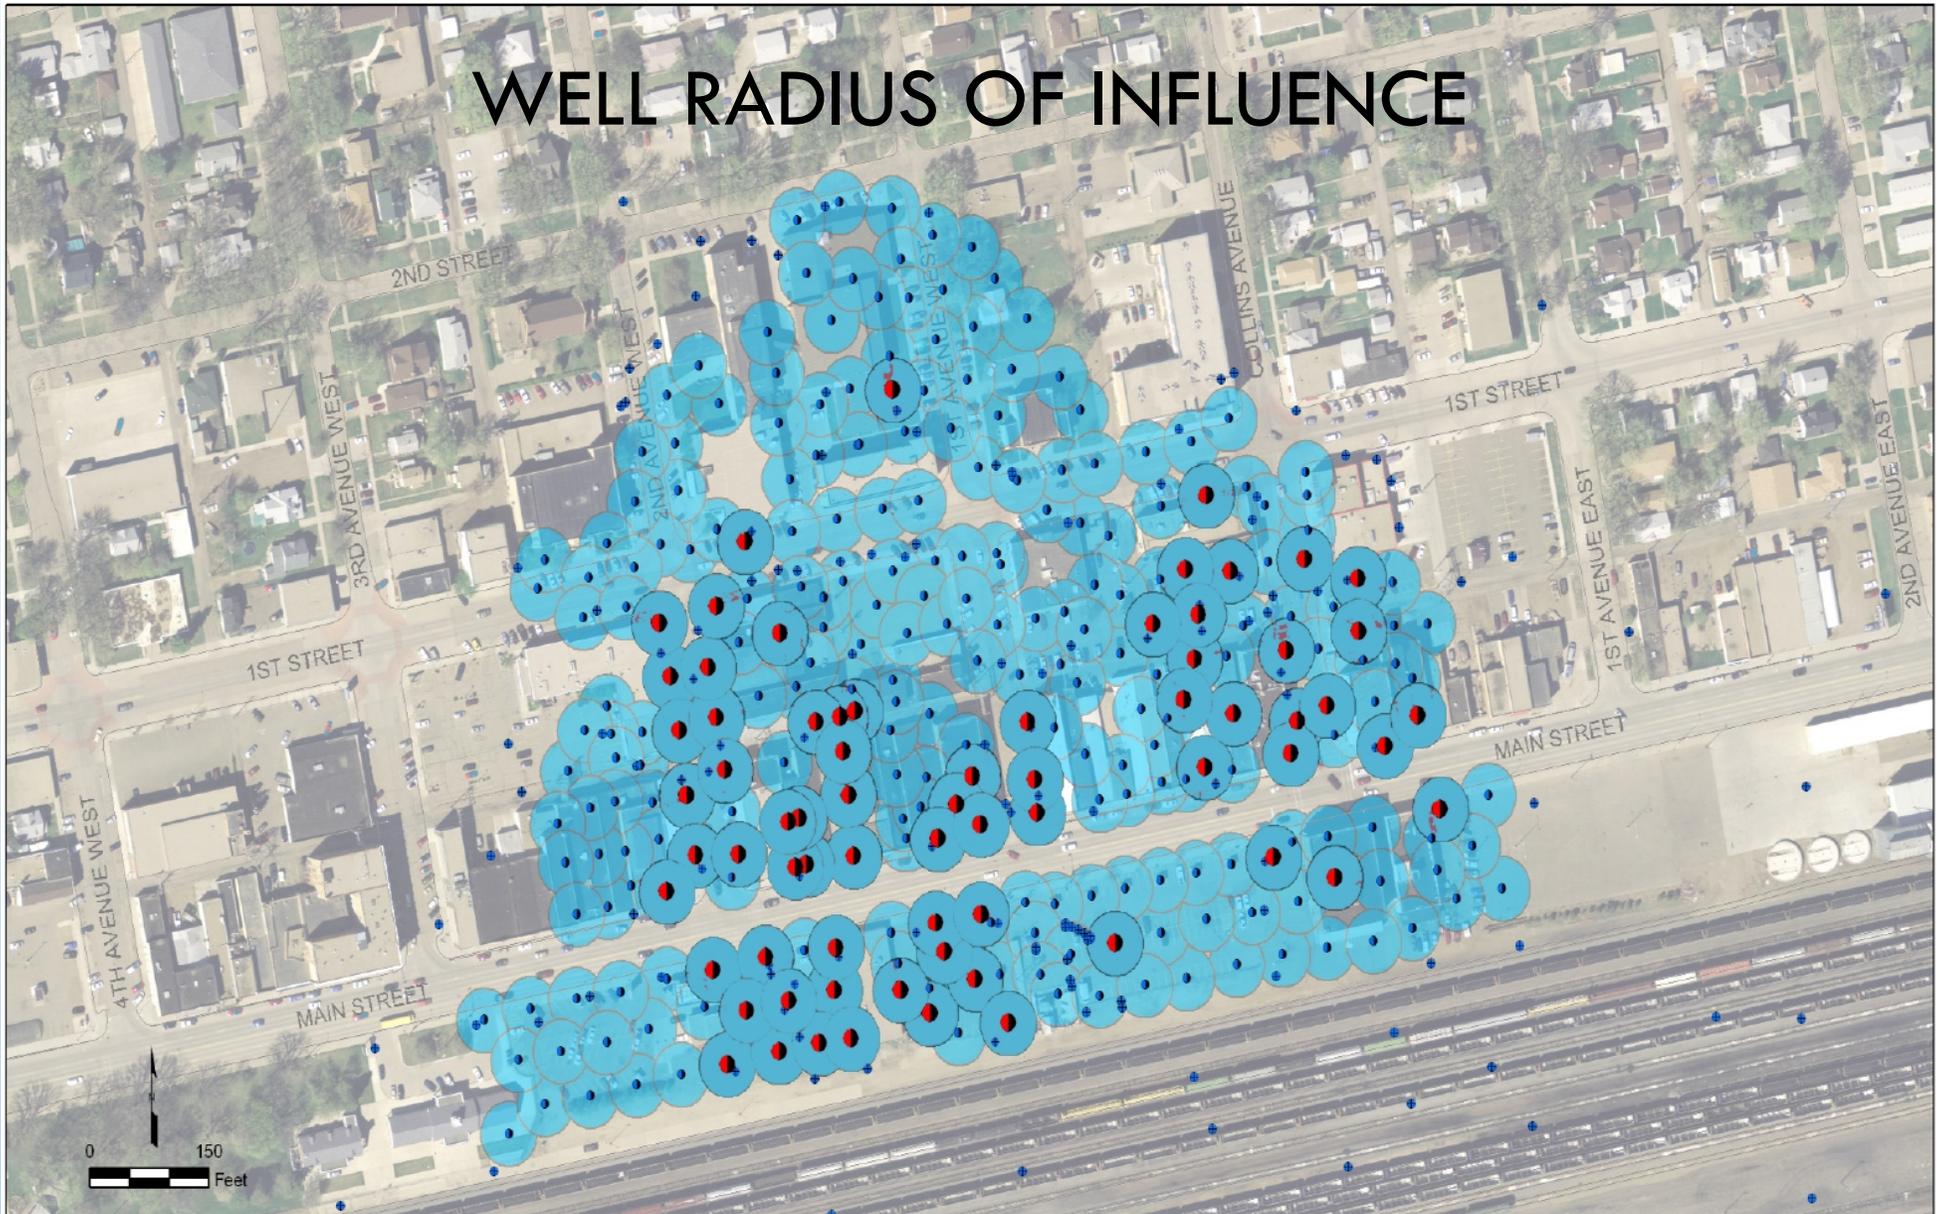
WELL RADIUS OF INFLUENCE

ROI (35 feet) for Wells in MPE Mode (November 2008)
-

ROI (35 feet) for Wells Not in MPE Mode (November 2008)

REMEDIAL WELLS IN MPE MODE (NOVEMBER 2008)

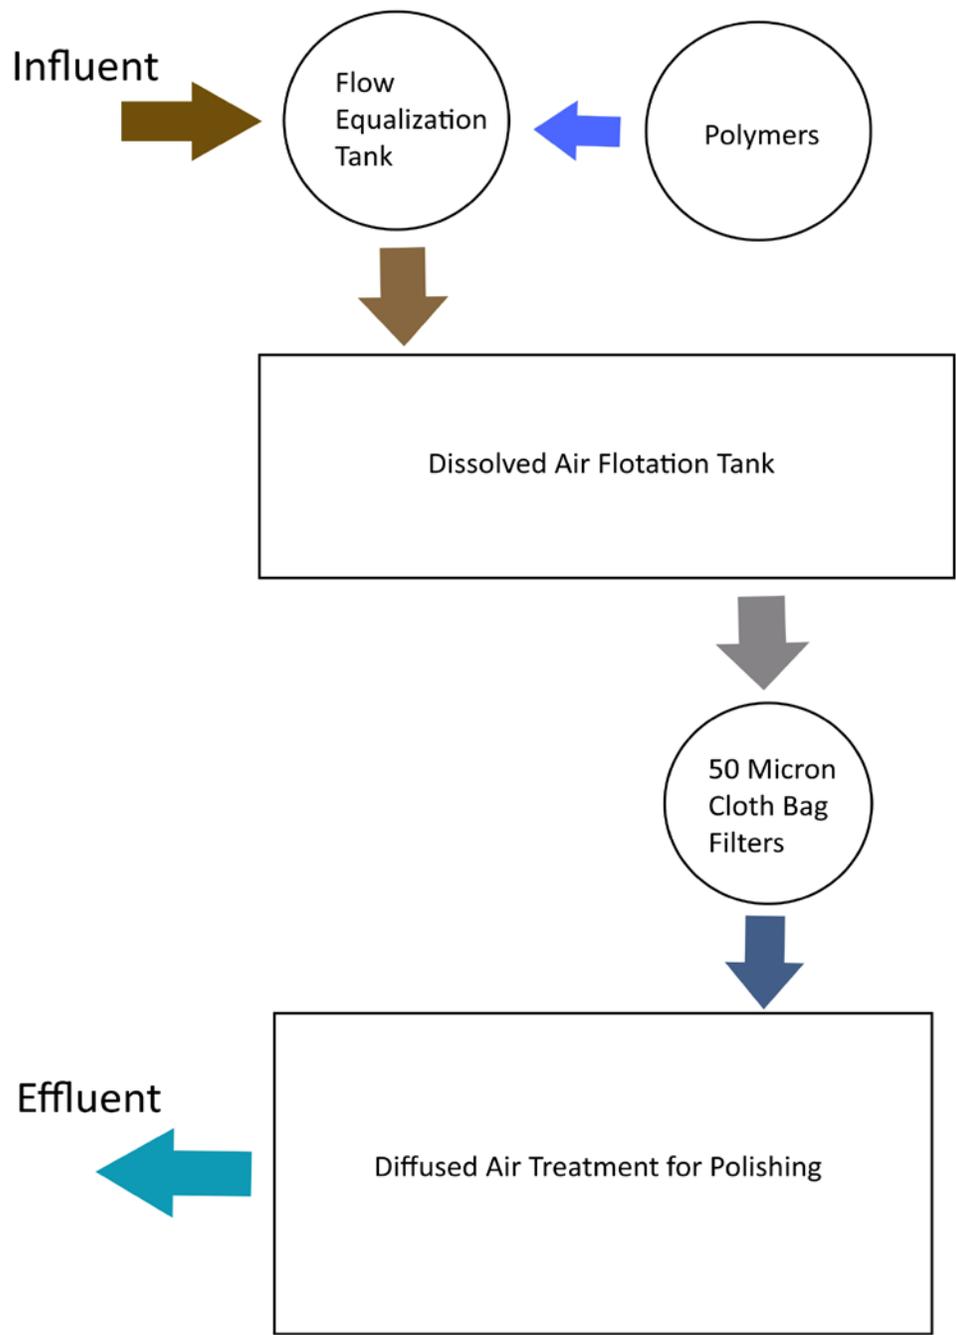
WASTE WATER TREATMENT SYSTEM SCHEMATIC

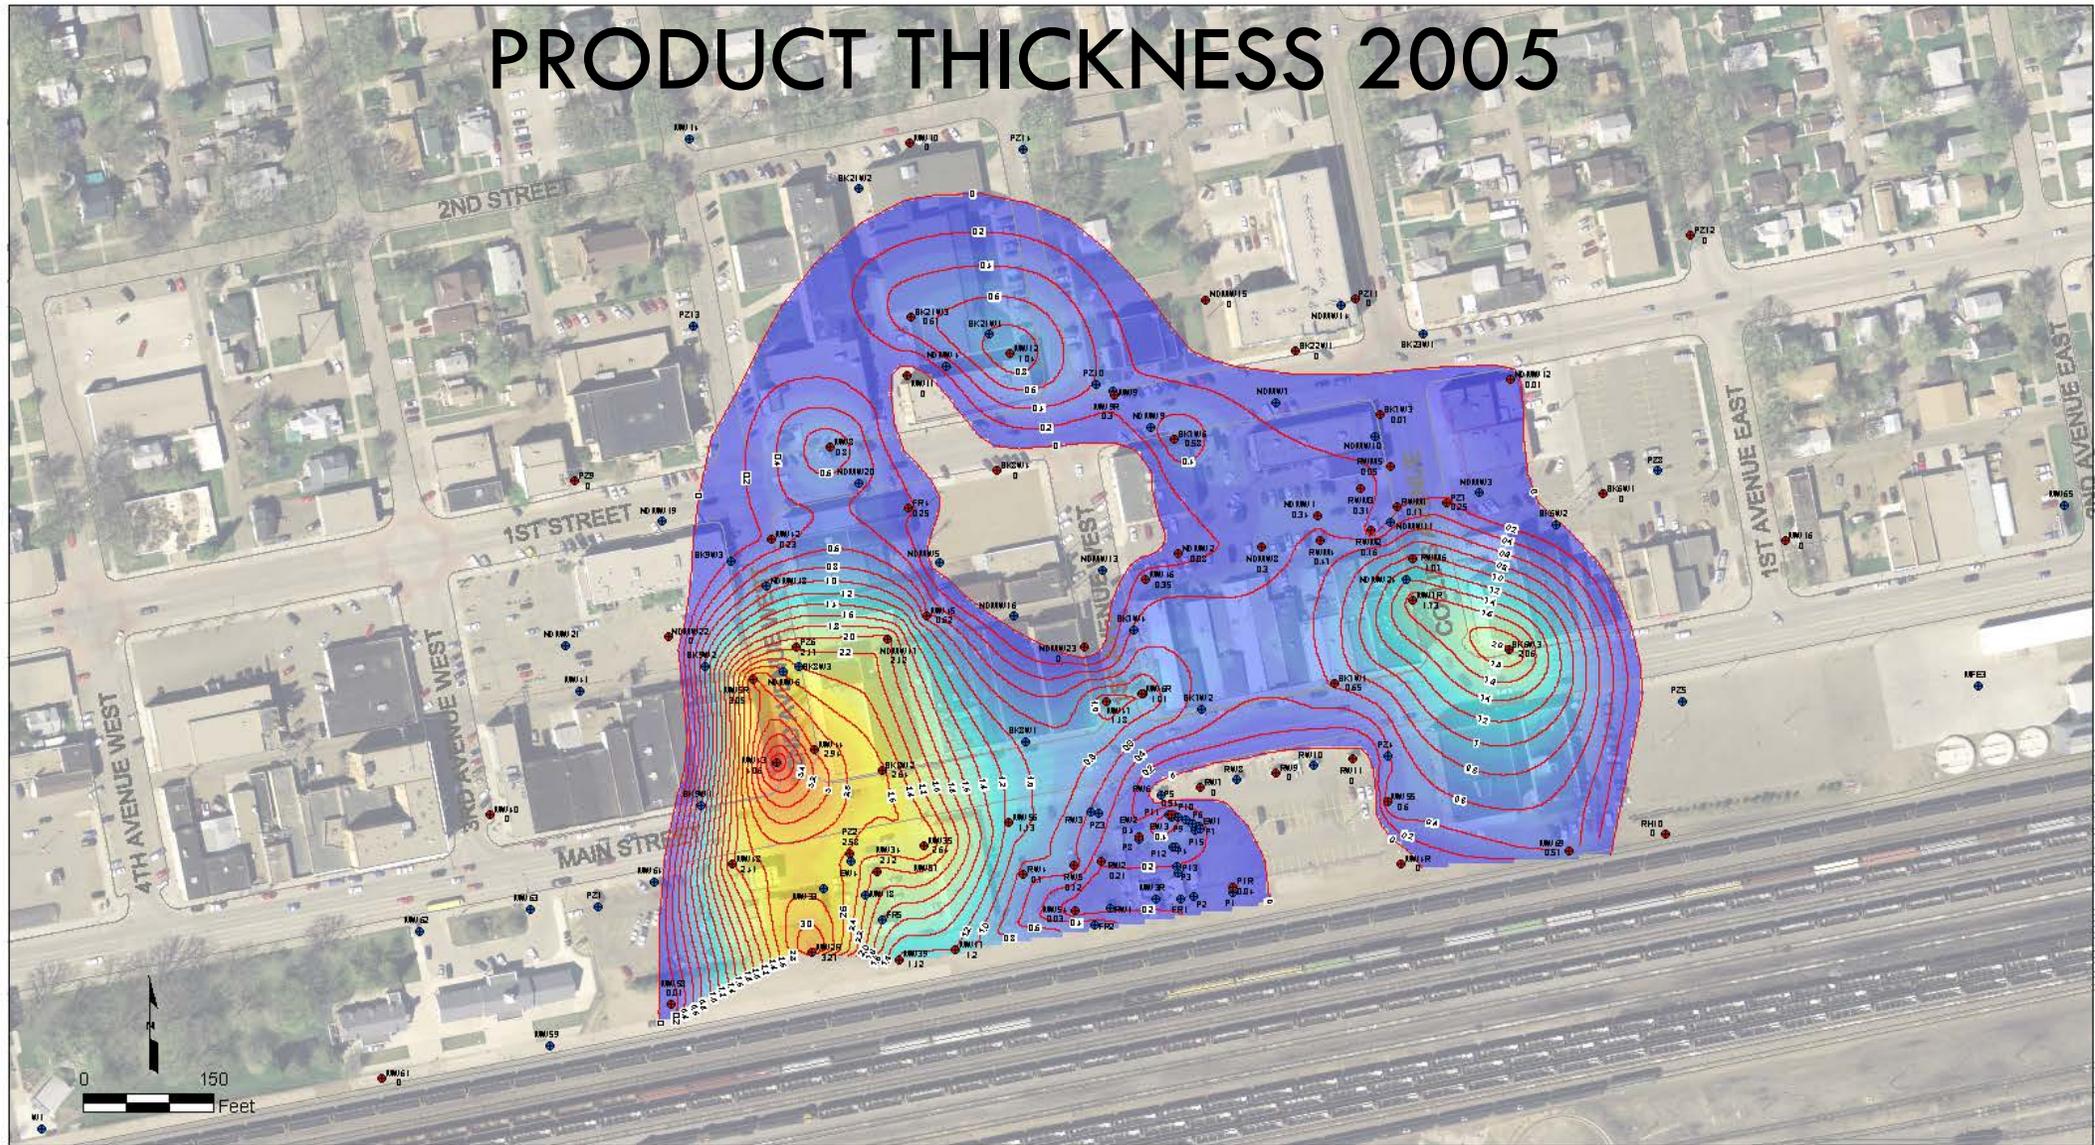
PRODUCT THICKNESS 2005

- Well Not Measured
- Well Measured March 2005
- 2.41 Product Thickness (feet)

MARCH 2005 FREE-PRODUCT THICKNESS

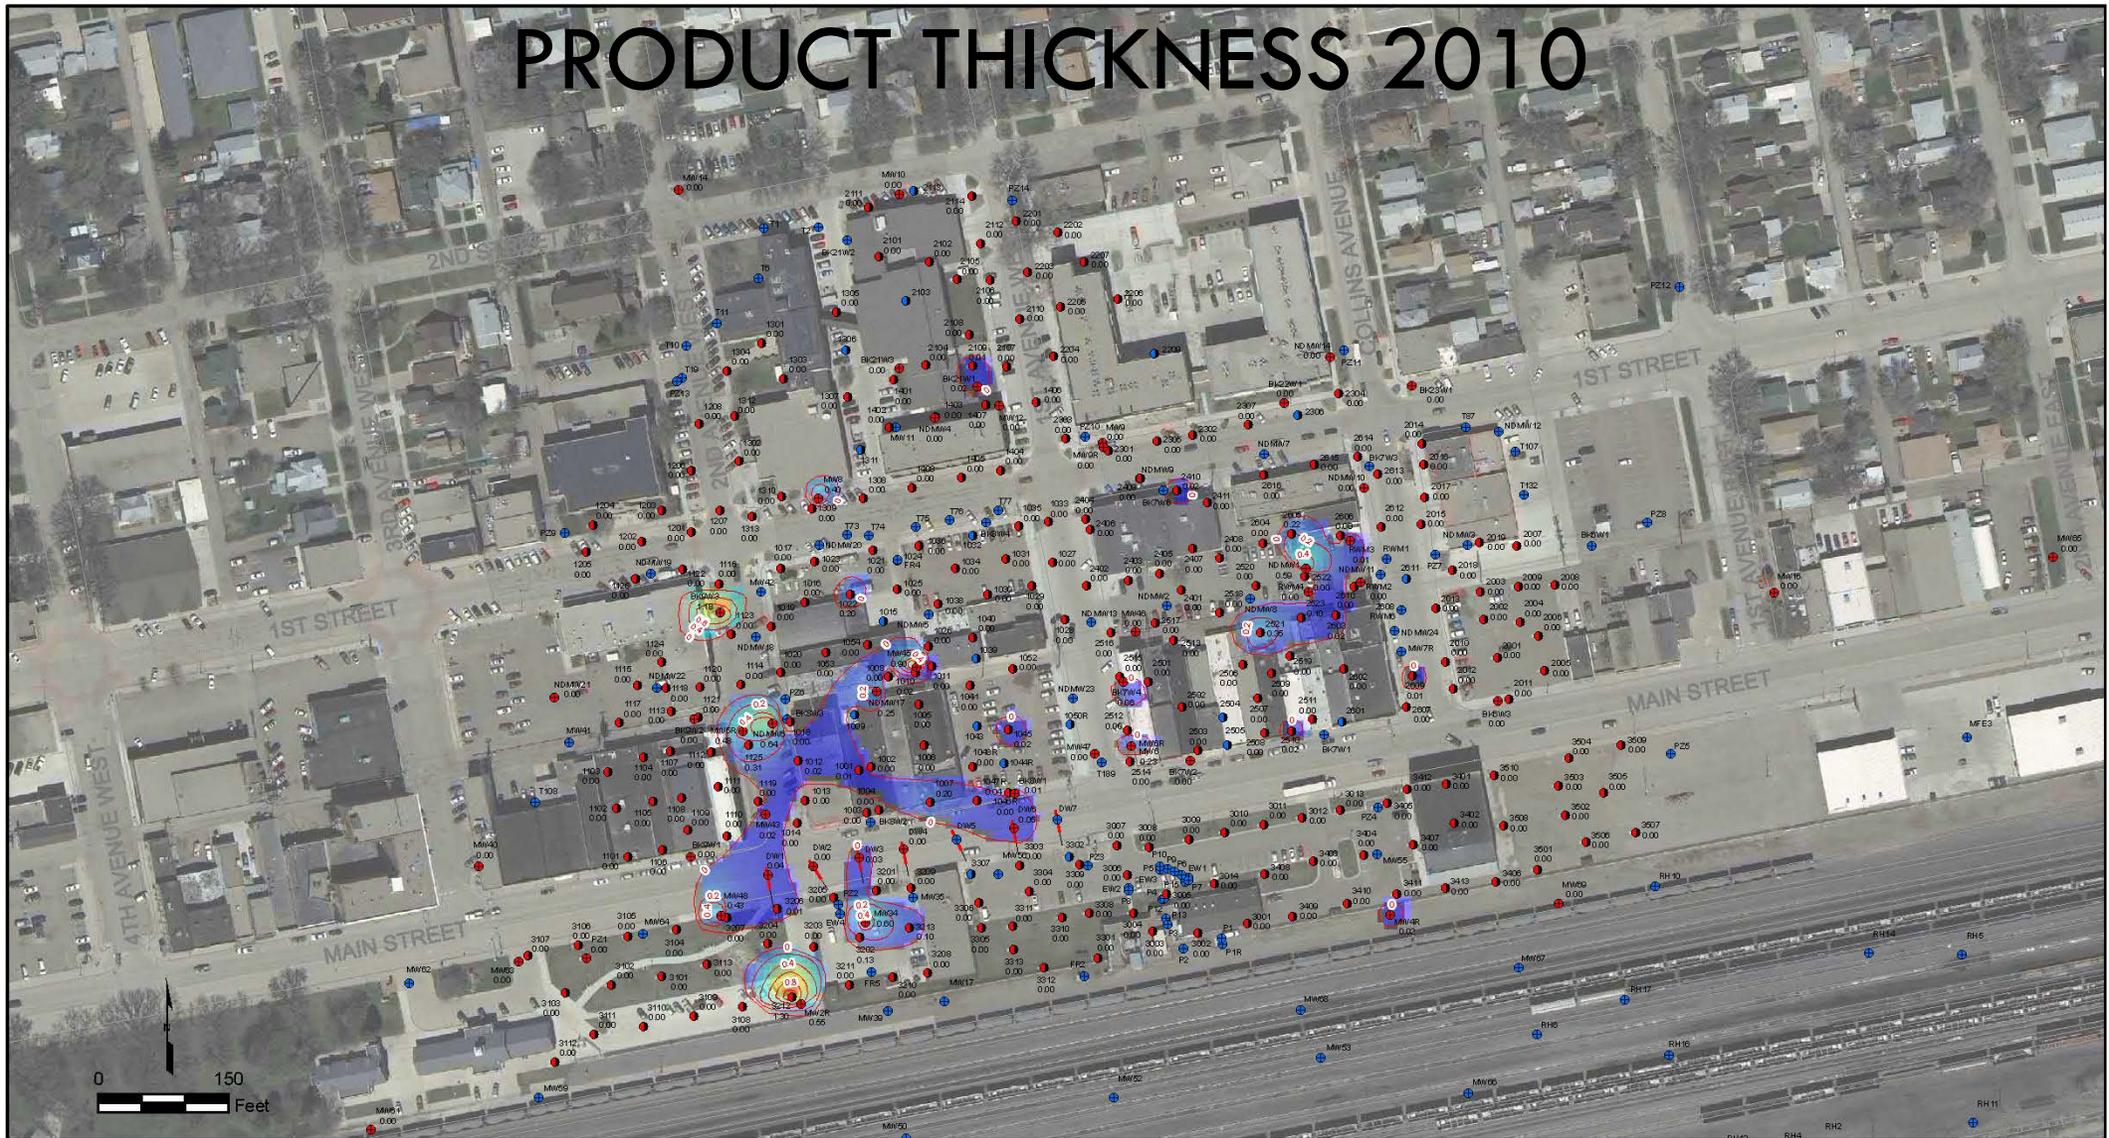
PRODUCT THICKNESS 2010

- Product Thickness**
- High : 1.3 feet
 - Low : 0.00 feet
- Product Thickness Contour (feet)**
- Monitoring / Remedial Well Not Measured
 - Monitoring / Remedial Well Measured
 - 0.48 Product Thickness (feet)

PRODUCT THICKNESS MAY/JUNE 2010

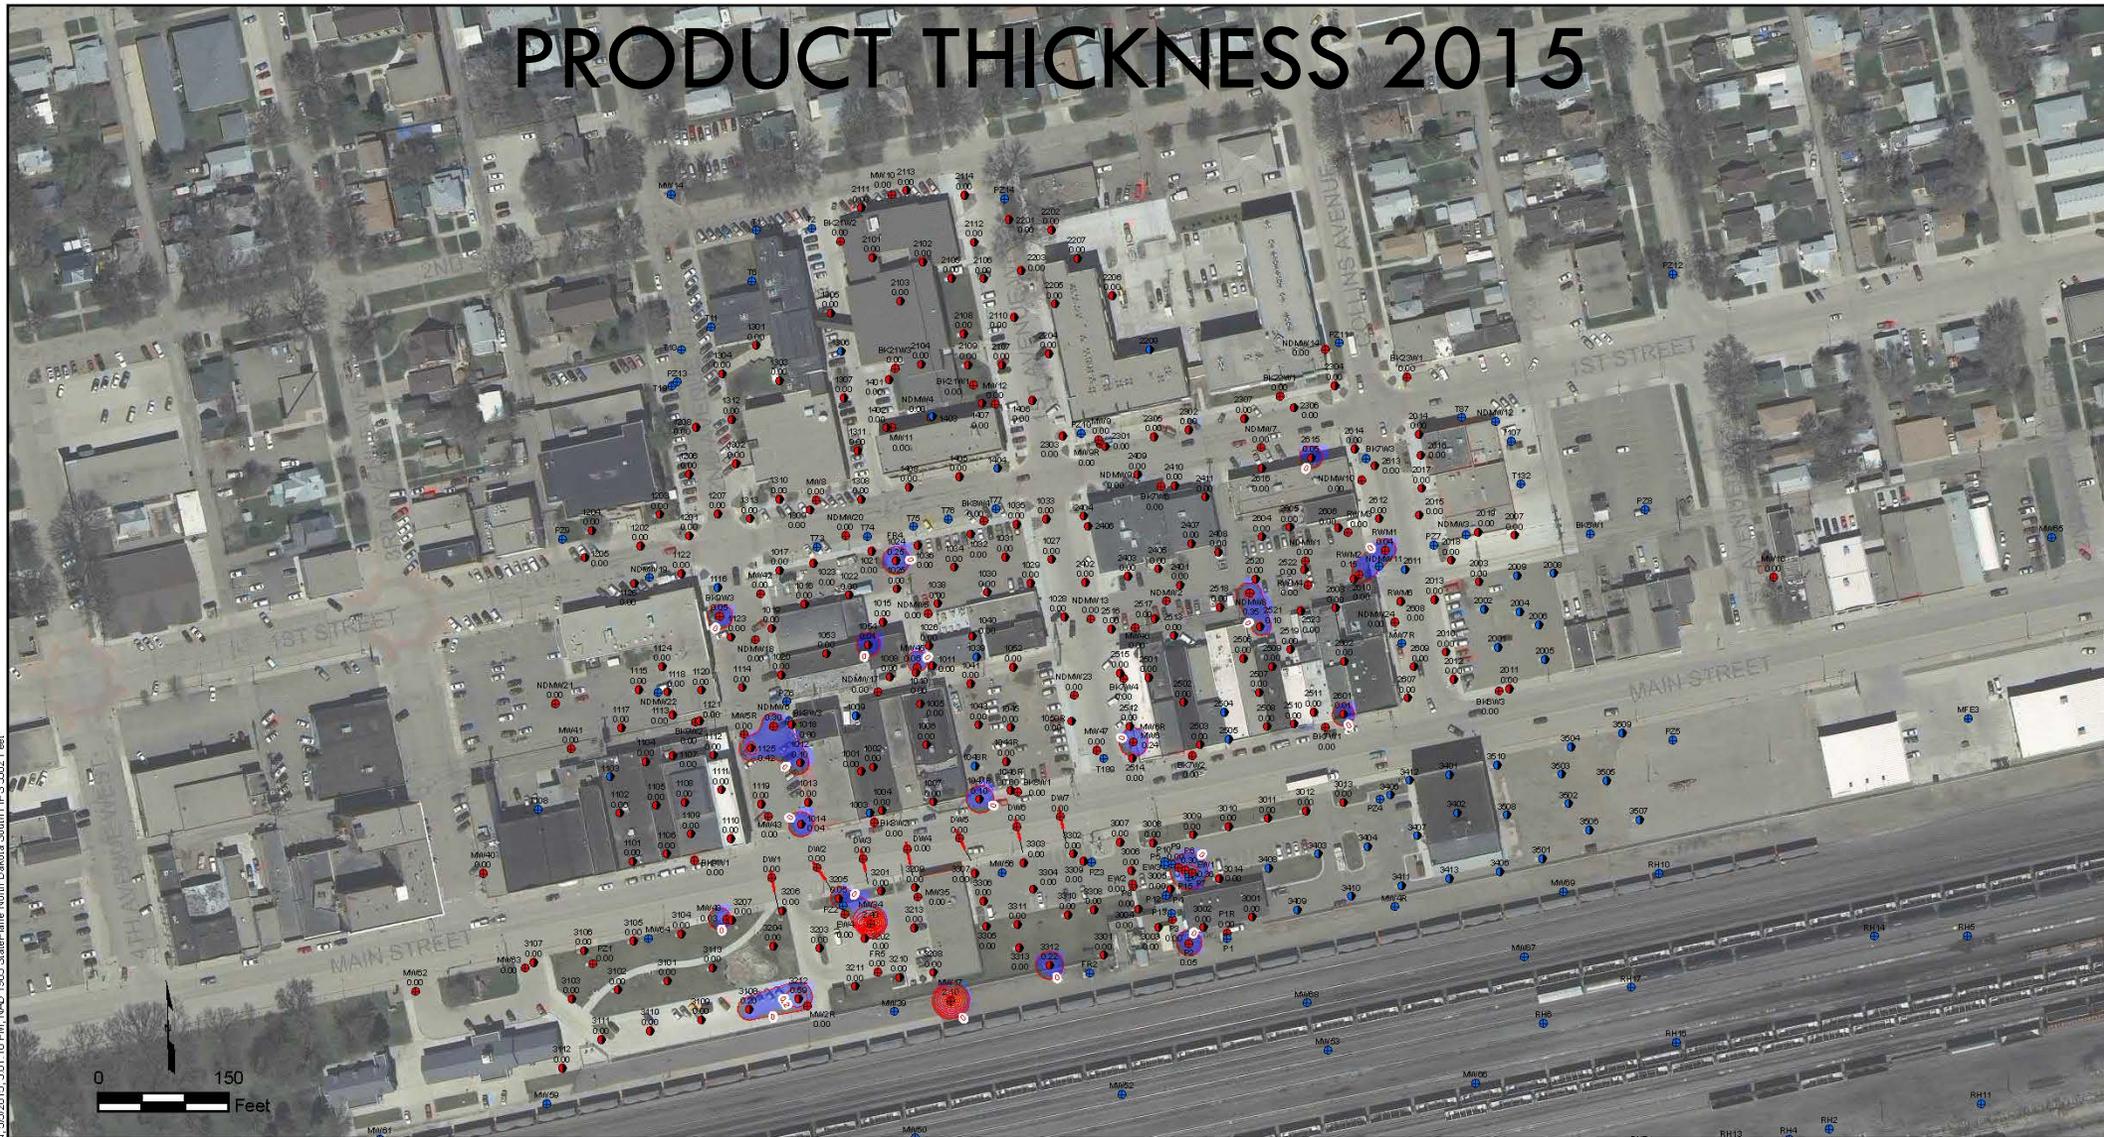
PRODUCT THICKNESS 2015

Product Thickness
 High : 2.40 feet
 Low : 0.00 feet

PRODUCT THICKNESS MARCH AND APRIL 2015

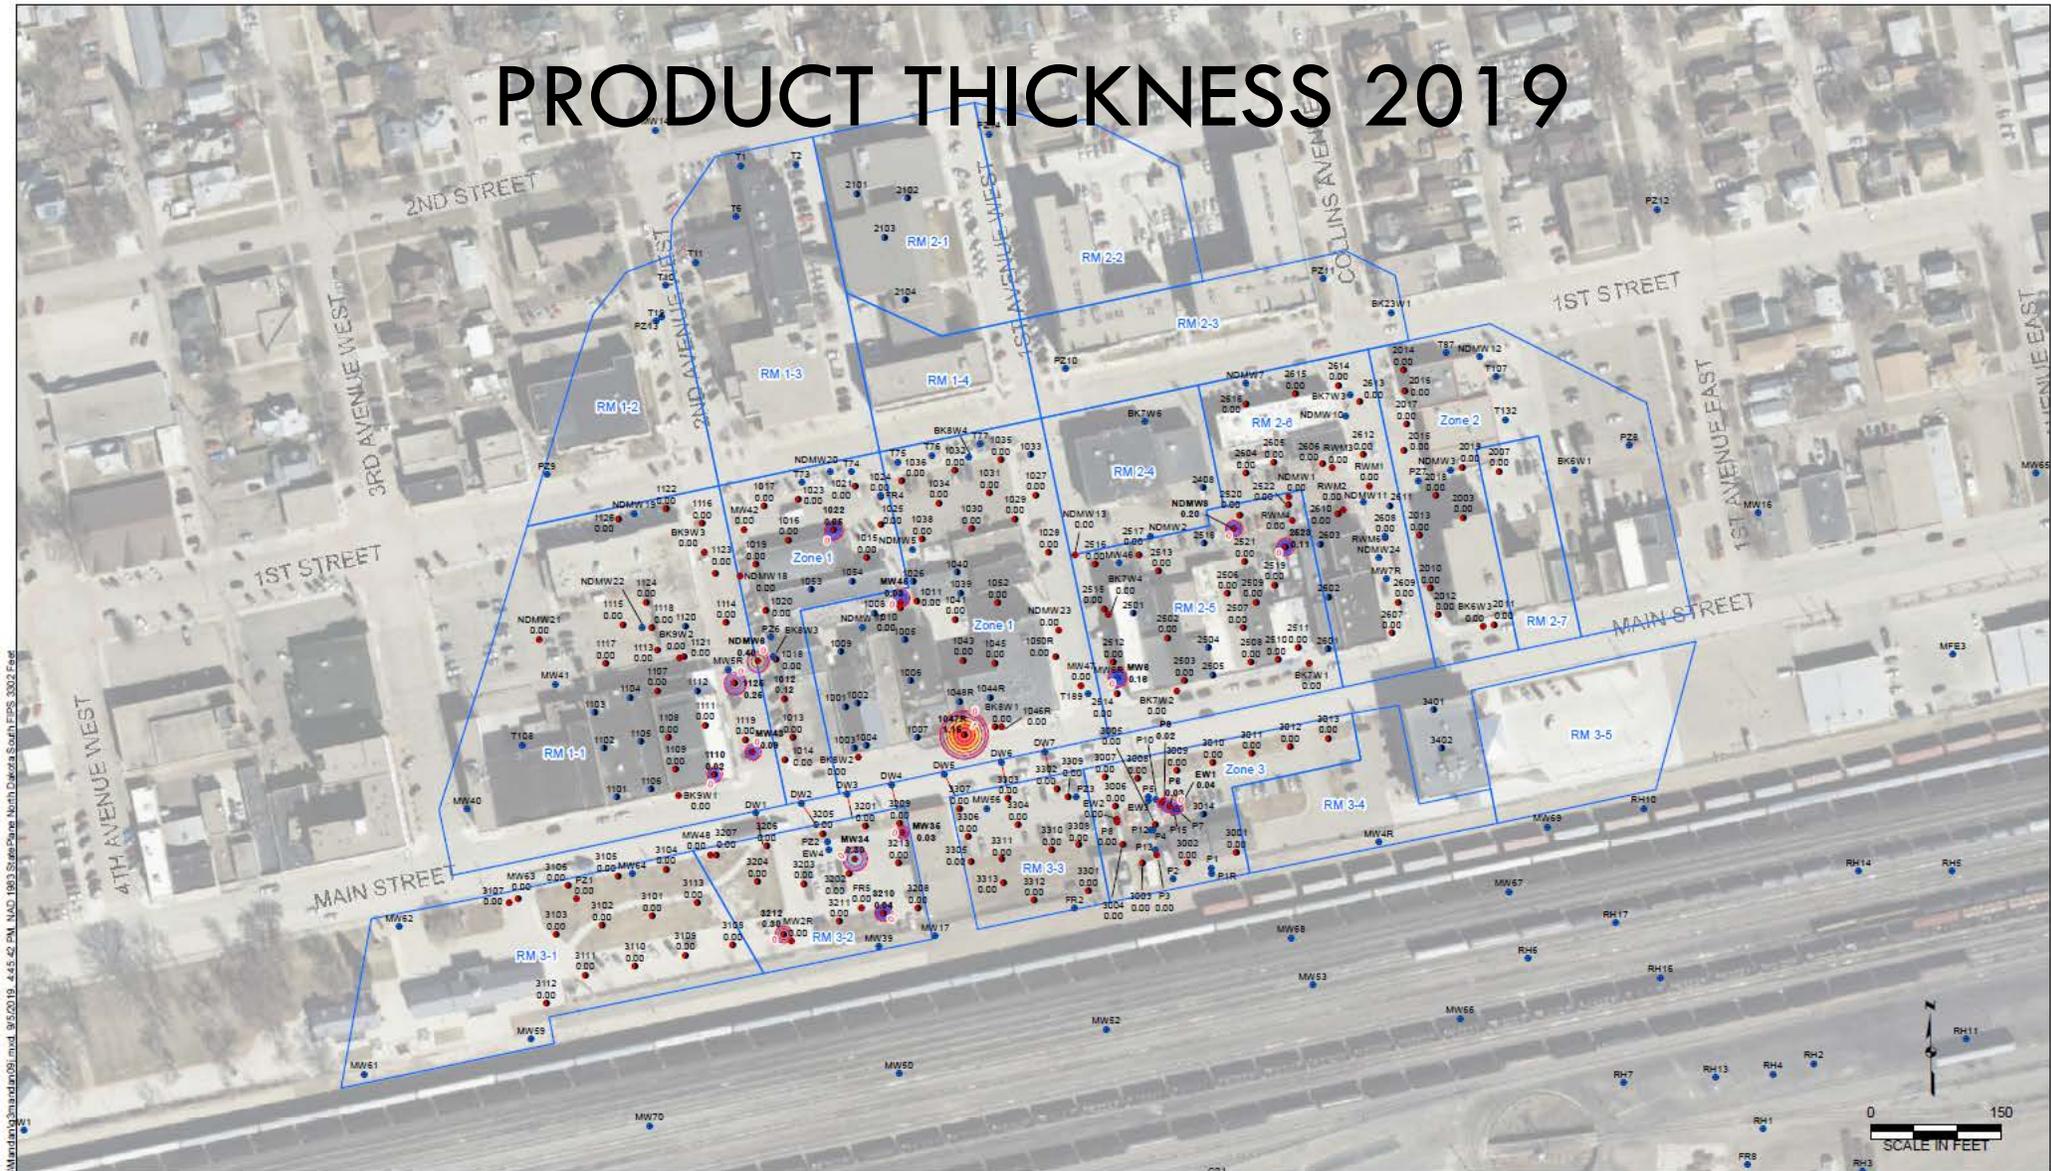
PRODUCT THICKNESS 2019

Product Thickness
 High : 1.15 feet
 Low : 0.00 feet

FIGURE 1
PRODUCT THICKNESS JULY-AUGUST 2019
